Mesa Verde National Park

Stabilization at 5MV3559, 5MV3543, 5MV3564

**Preservation Maintenance Assessment at 5MV542, 5MV544,
5MV548**

Field Season 2000

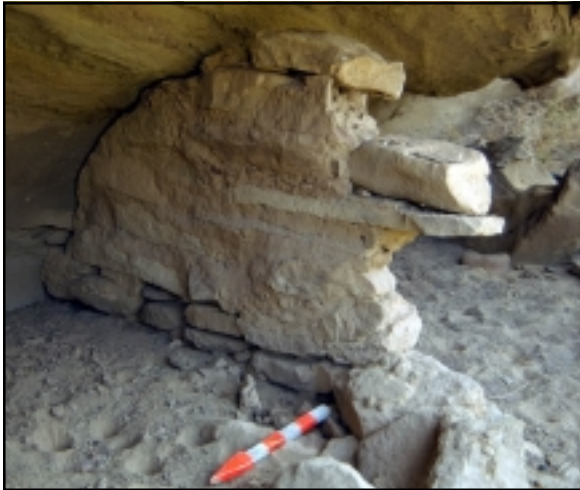
Figure 3.3. Room 1 South Wall Interior, Pre-Treatment.

On the interior south wall of Room 1, the basal portion of the wall was repointed with one small stone added (replaced) to help fill a void. On the western end of this wall, a large tabular stone had no support from below (Figure 3.3). Two loose wall stones, which were no longer part of the wall construction, and two additional stones were shaped from pieces of spall from the roof of the alcove were dry-laid under the unsupported stone. These stones were stacked one on top of the other and fitted snugly under the hanging tabular stone to provide support. A few smaller stones were used as wedges to

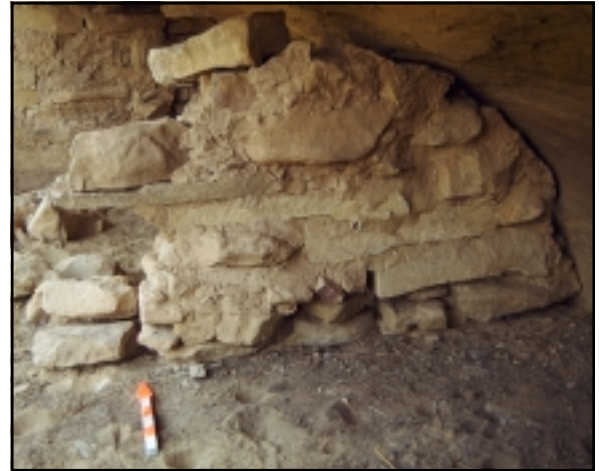
Figure 3.5. Room 1 South Wall Exterior, Pre-Treatment.

The exterior south wall of Room 1 was repointed; mainly filling a large void along the base where four large stones were reset (Figure 3.5). Four smaller stones were also used to help fill in a void in the middle basal portion of the wall (Figure 3.6).

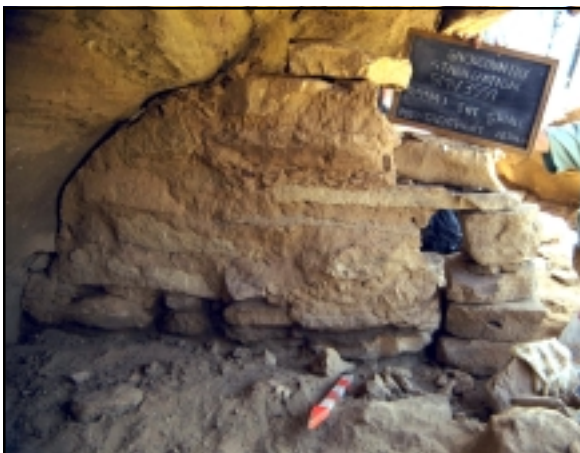
Figure 3.4. Room 1 South Wall Interior, Post-Treatment.

keep the larger ones upright (Figure 3.4).

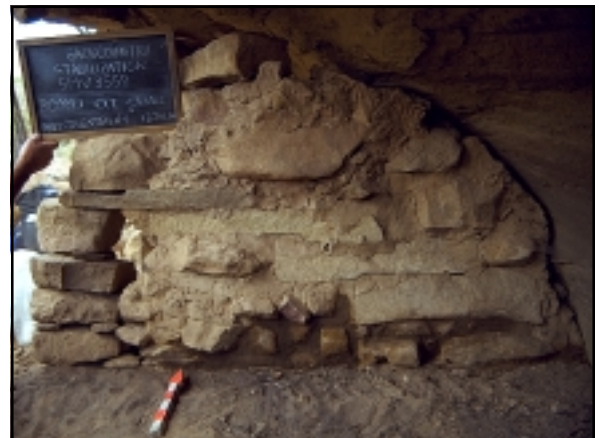
Figure 3.6. Room 1 South Wall Exterior, Post-Treatment.

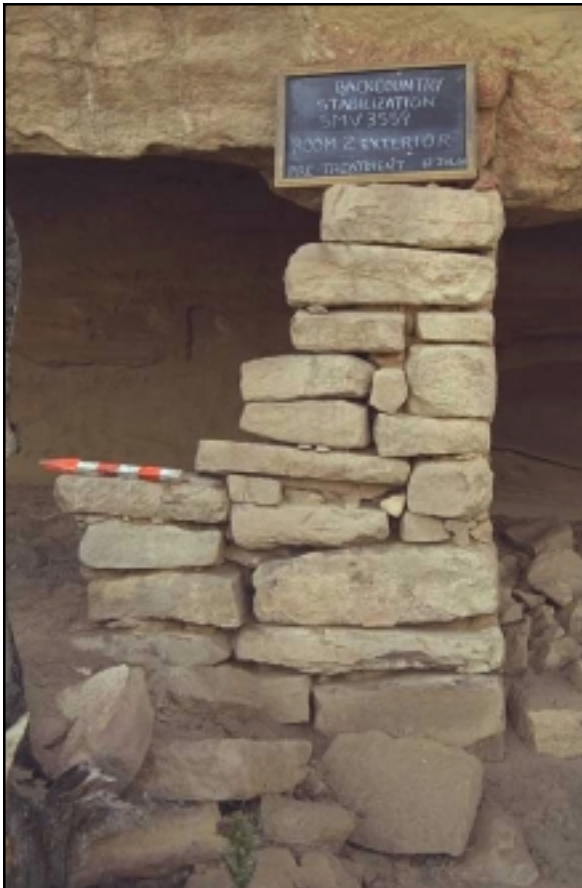
The west-facing wall of this room needed the most attention in terms of treatment. This wall needed to be completely repointed. Due to its western exposure, there was extensive mortar loss. The wall had only had minimal protection from the alcove overhang (Figure 3.7). There were no loose stones to be reset and no stones needed replacement. A few chinking stones were still present in the prehistoric mortar so new chinking stones were added to match the prehistoric pattern present on

Figure 3.7. Room 2 Exterior West Wall, Pre Treatment.

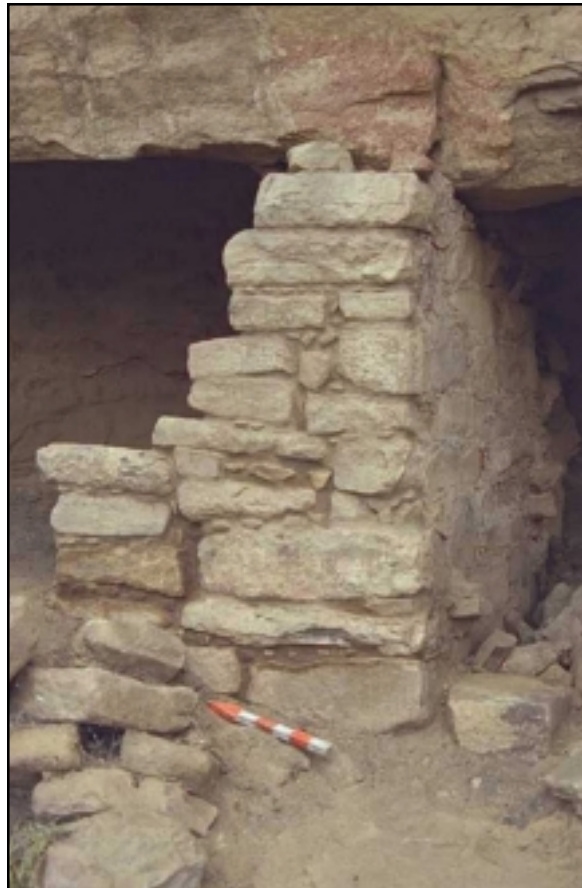
Figure 3.8. Room 2 Exterior West Wall, Post Treatment.

the exterior wall (Figure 3.8) These chinking stones were mostly spalls. The interior of this west wall needed only minimal repointing. No chinking stones were placed on this side of the wall since none were present in the existing aboriginal mortar.

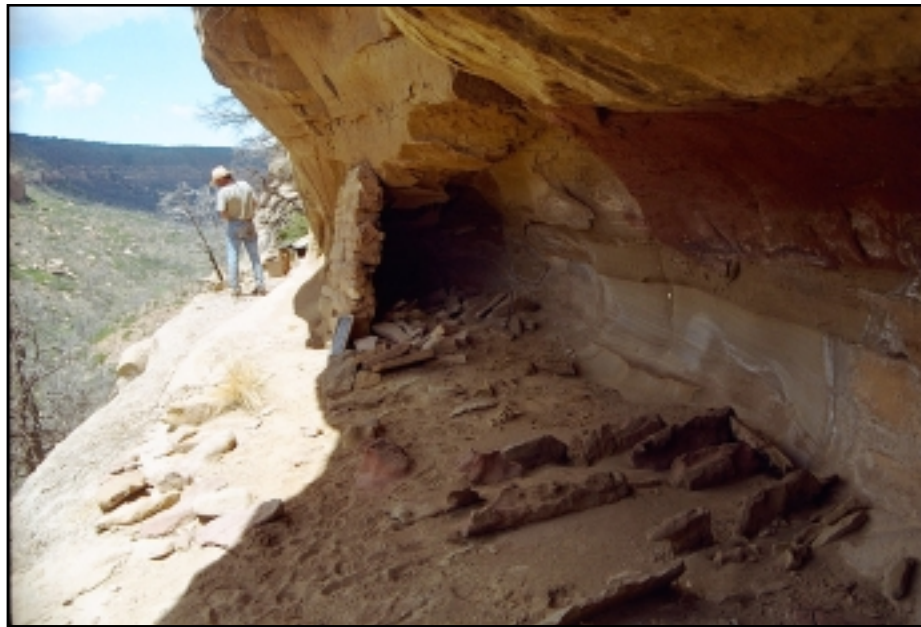
At 5MV3543, the condition assessment crew identified the basal course of the only wall standing (Room 1, west wall) as needing repointing. In addition, the northern end of the same wall was suffering from severe mortar loss (Figure 4.2).

Figure 4.2. Site overview looking North.

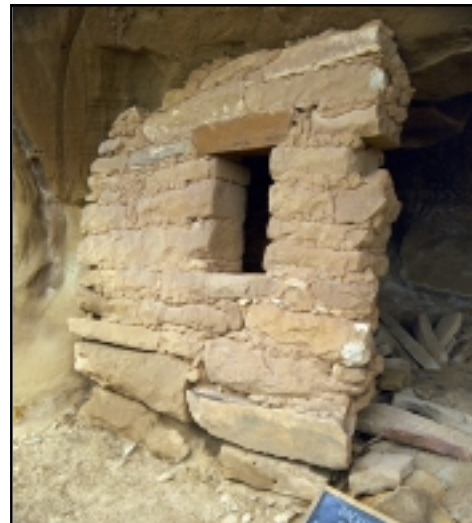
The condition assessment crew visited 5MV3543 in 1997. They noted that the one standing wall suffered from basal erosion as the wall was exposed directly to weather. The alcove affords only minimal protection. This alcove has a western exposure and is often hammered by incoming weather fronts. The proximity of the wall to the outer edge of the alcove contributed to the basal erosion as water from the alcove dripline was running down directly onto the wall (Figure 4.3).

Figure 4.3. Room 1 Exterior West Wall, Pre-Treatment.

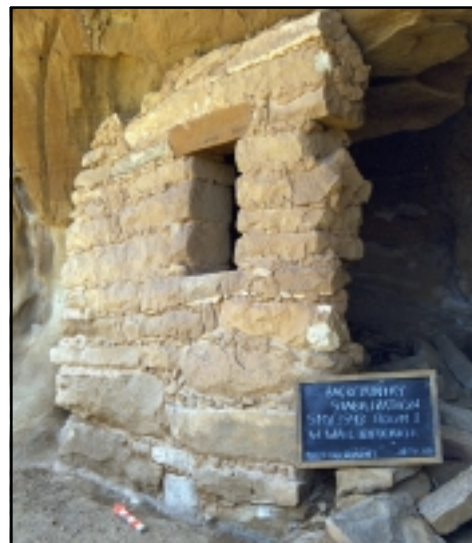
Figure 4.4. Room 1 Exterior West Wall, Post Treatment.

Treatment intervention on this wall consisted of repointing along the basal joints, adding chinking stones to match the original construction techniques. In addition to this, four stones were added to fill a void between the basal and first courses; only three of these are visible. Two stones were also used to fill a void between the north end of the first wall course and the alcove wall. These stones were chipped to shape where necessary (Figure 4.4).

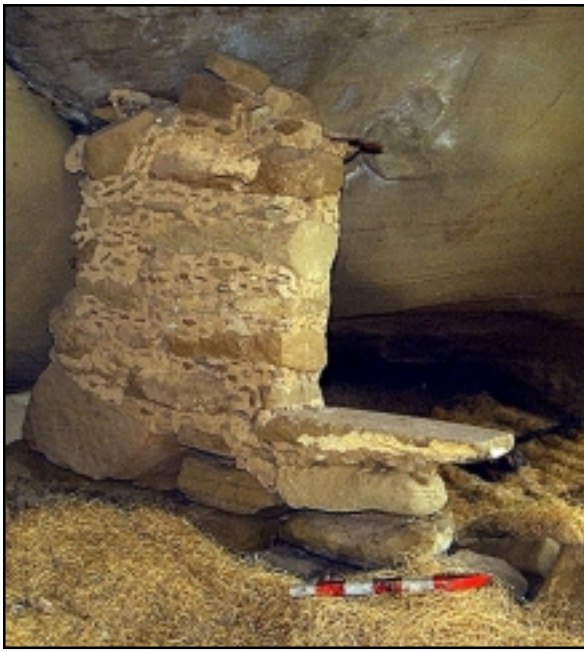
Figure 5.2. Room 1 Exterior East Wall, Pre-Treatment.

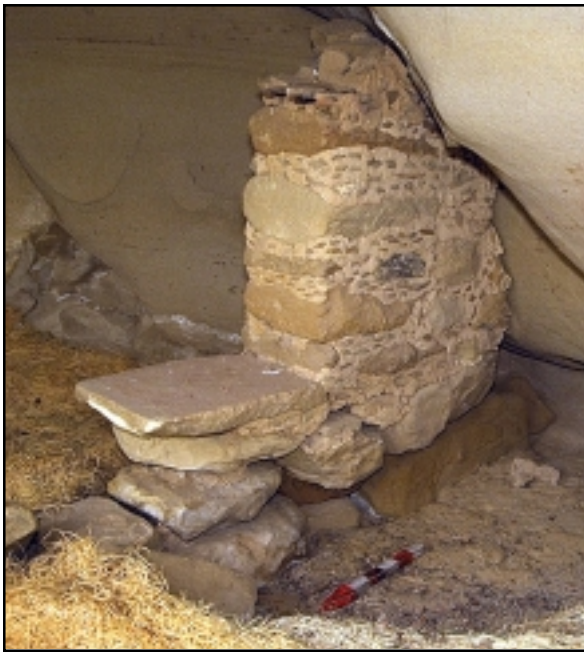
Figure 5.3. Room 1 Interior East Wall, Pre-Treatment.

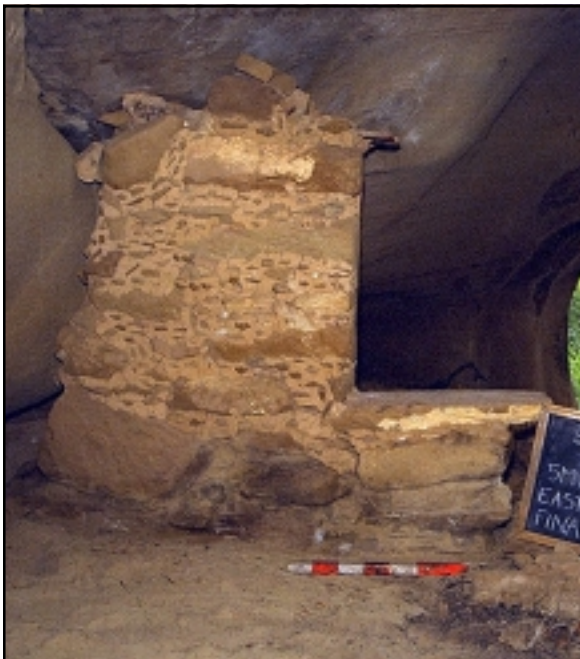
Figure 5.5. Room 1 exterior east wall, post treatment.

east wall of Room 1 were repointed. Two voids were filled with three stones and a void on the east exterior was filled with a replaced stone (Figure 5.5) (Figure 5.6). In addition, Fritz was responsible for photo and mapping documentation, and completion of the forms.

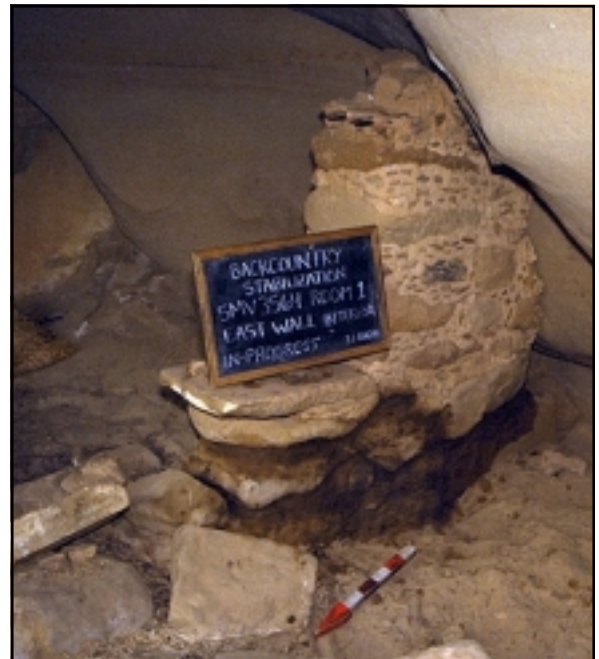
Figure 5.6. Room 1 interior east wall, post treatment.
